Damage and Recovery From the 2014 Polar Vortex

National Nuclear Security Administration Tritium Facilities
at the Savannah River Site

Jimmy Guerry
Safety System Oversight Engineer
Savannah River Field Office

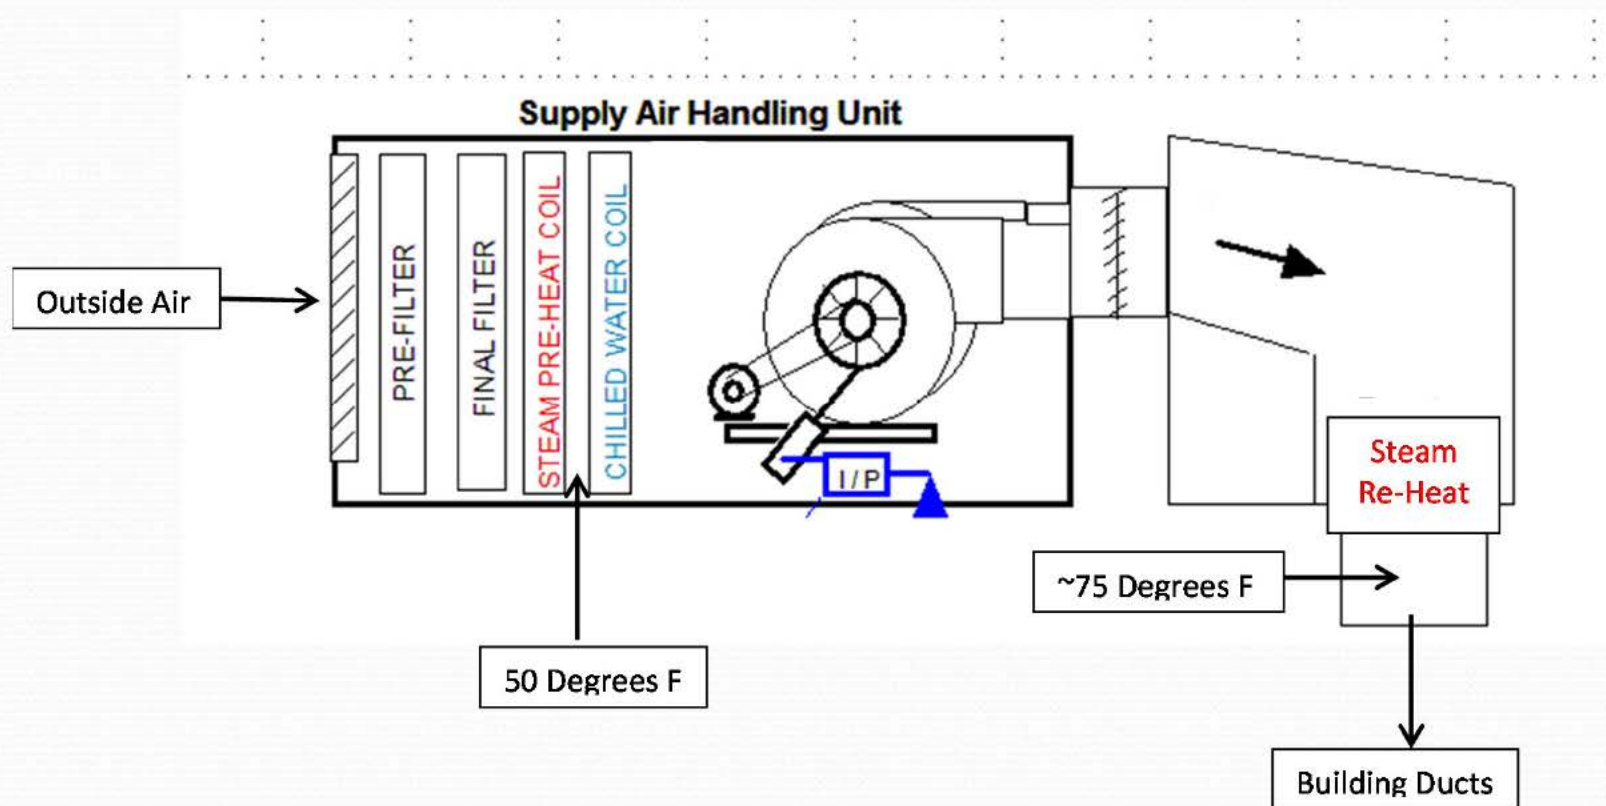
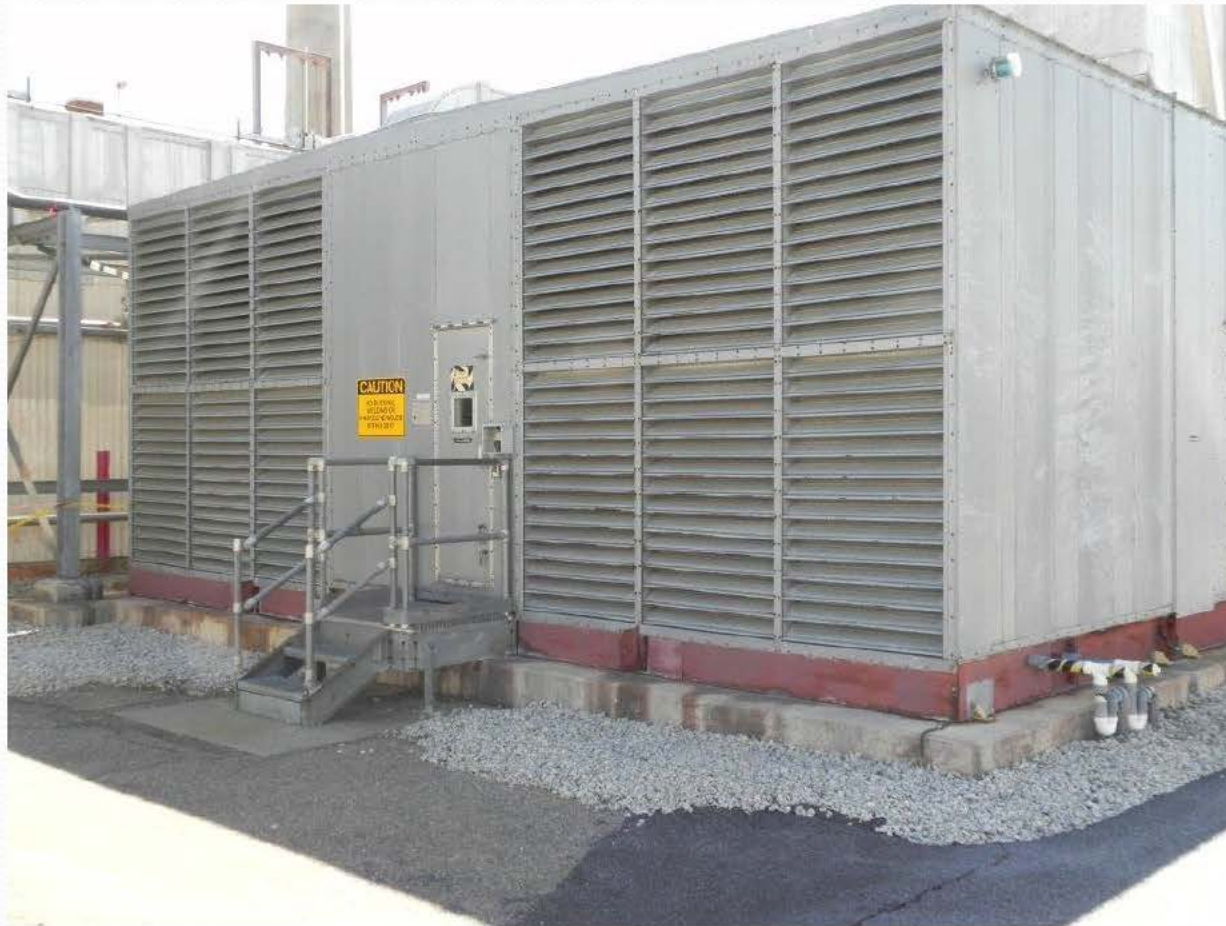
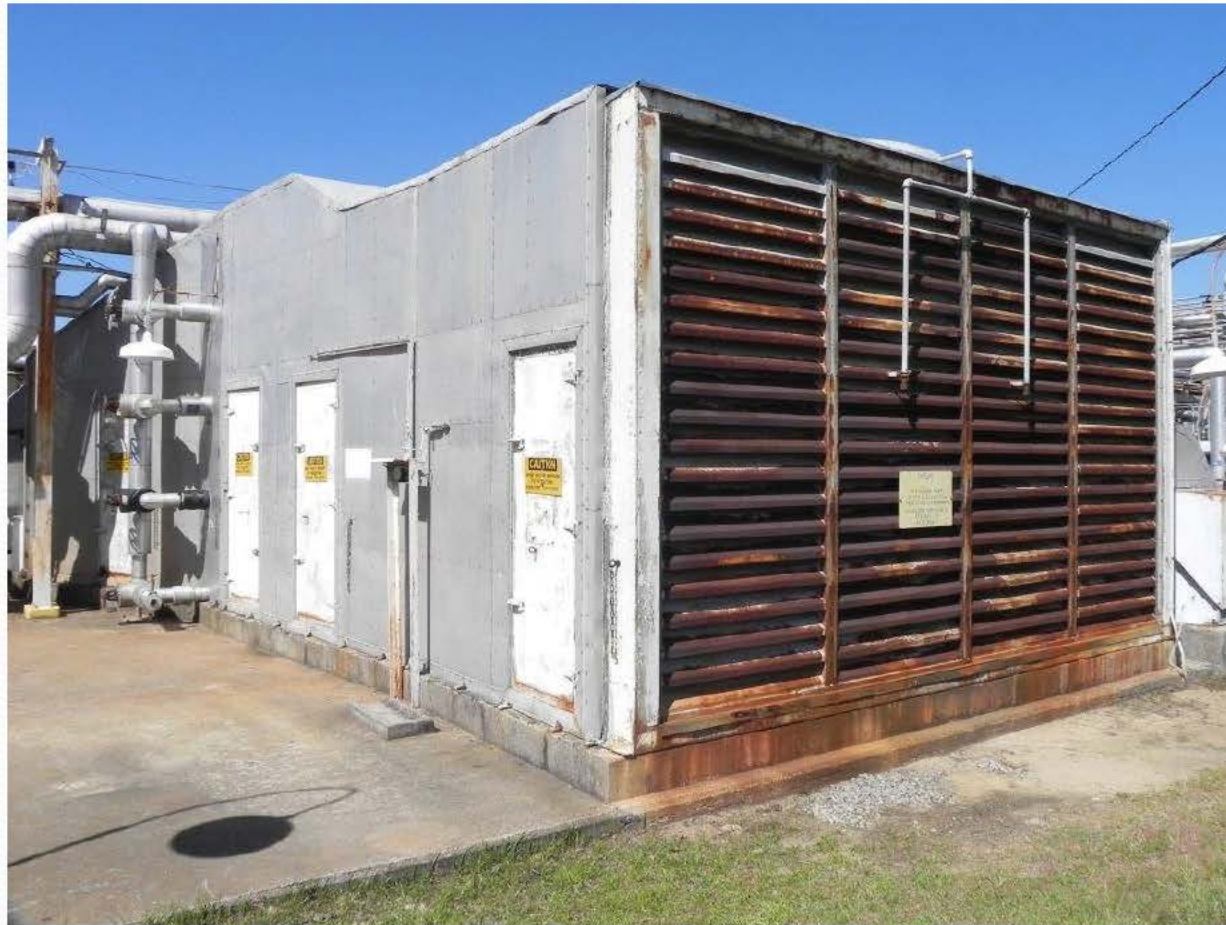
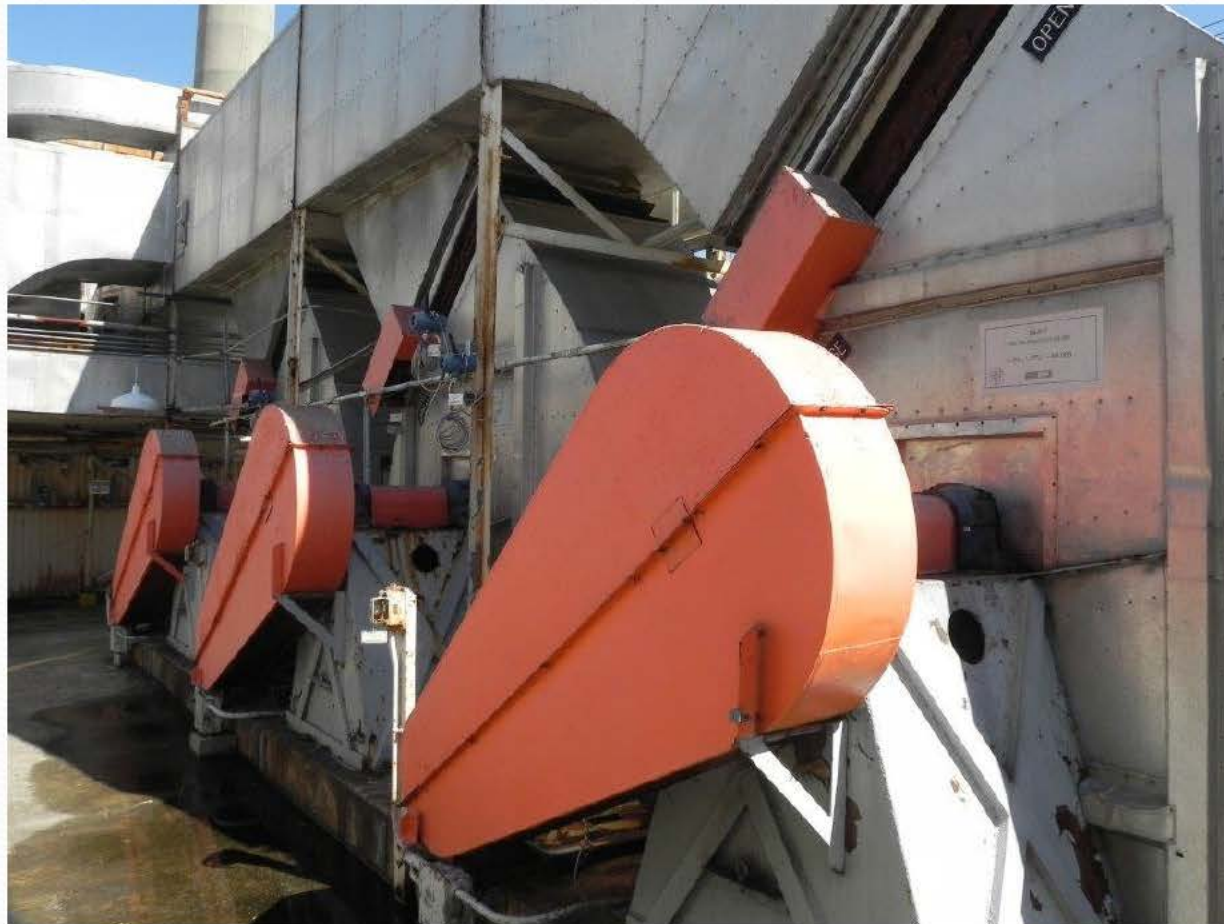
During the late night hours of January 6 the Biomass facility experienced freezing sensing lines on critical instrumentation that tripped both boilers off line. The Plant was unable to restore steam quickly and the steam header was closed around 0230 hours on January 7.

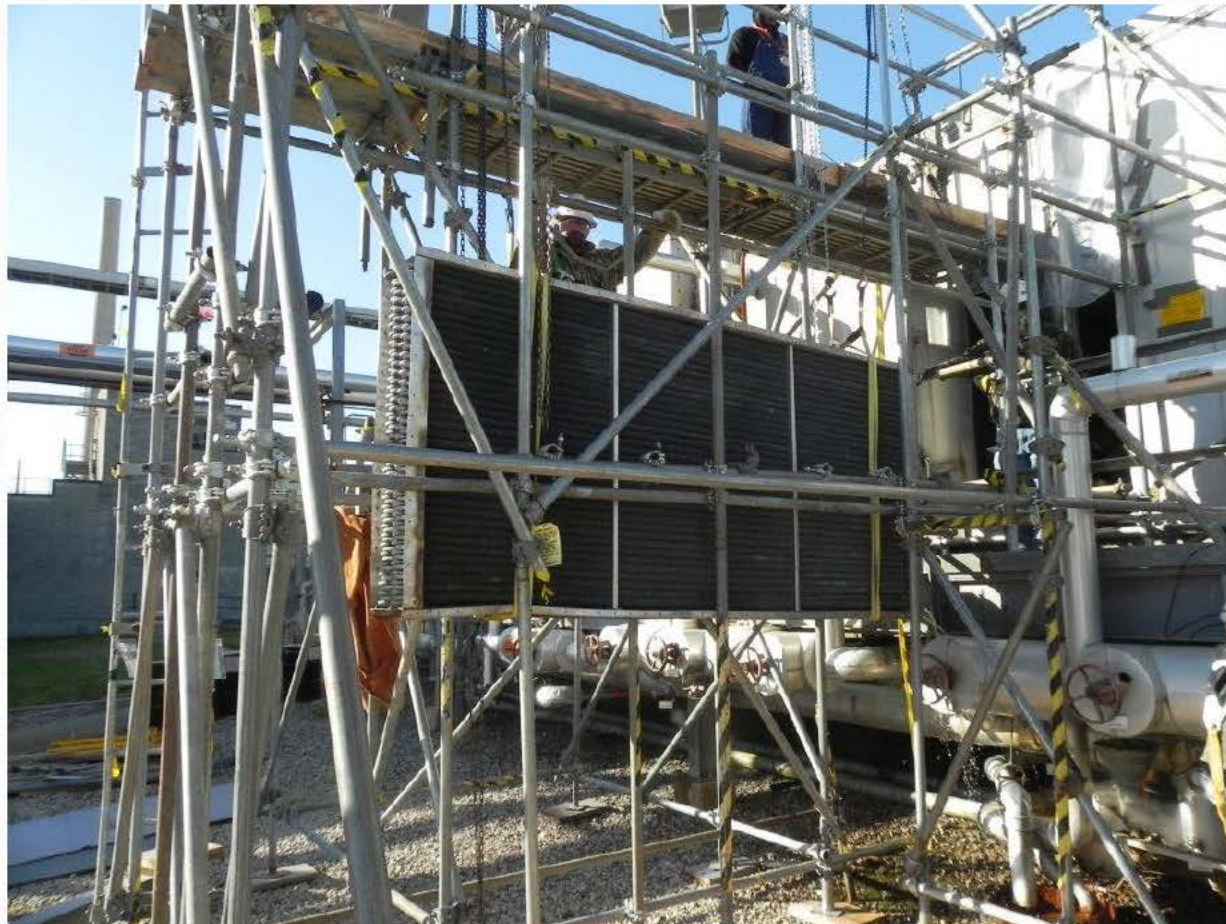
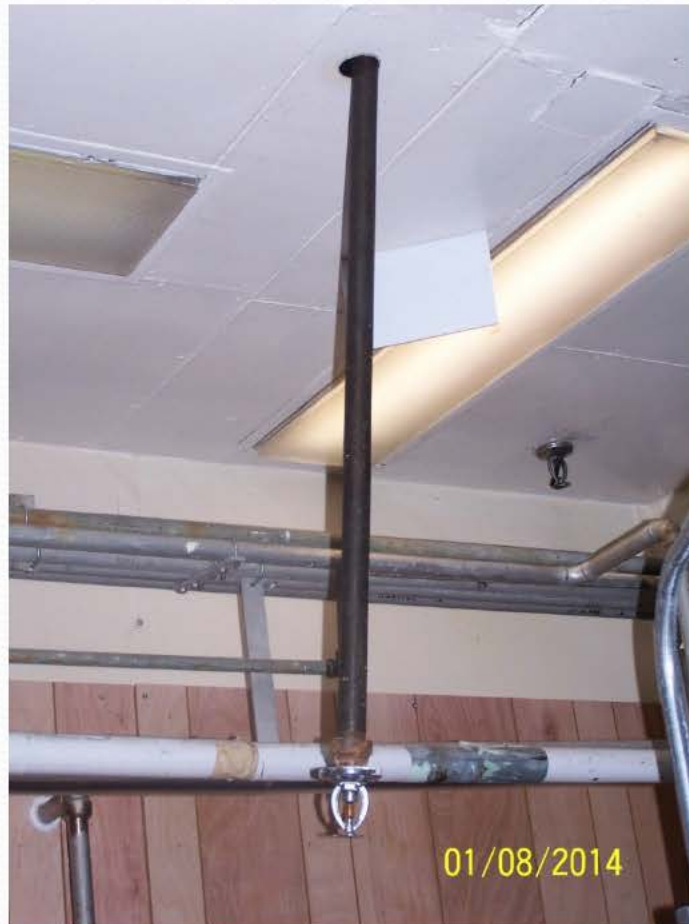
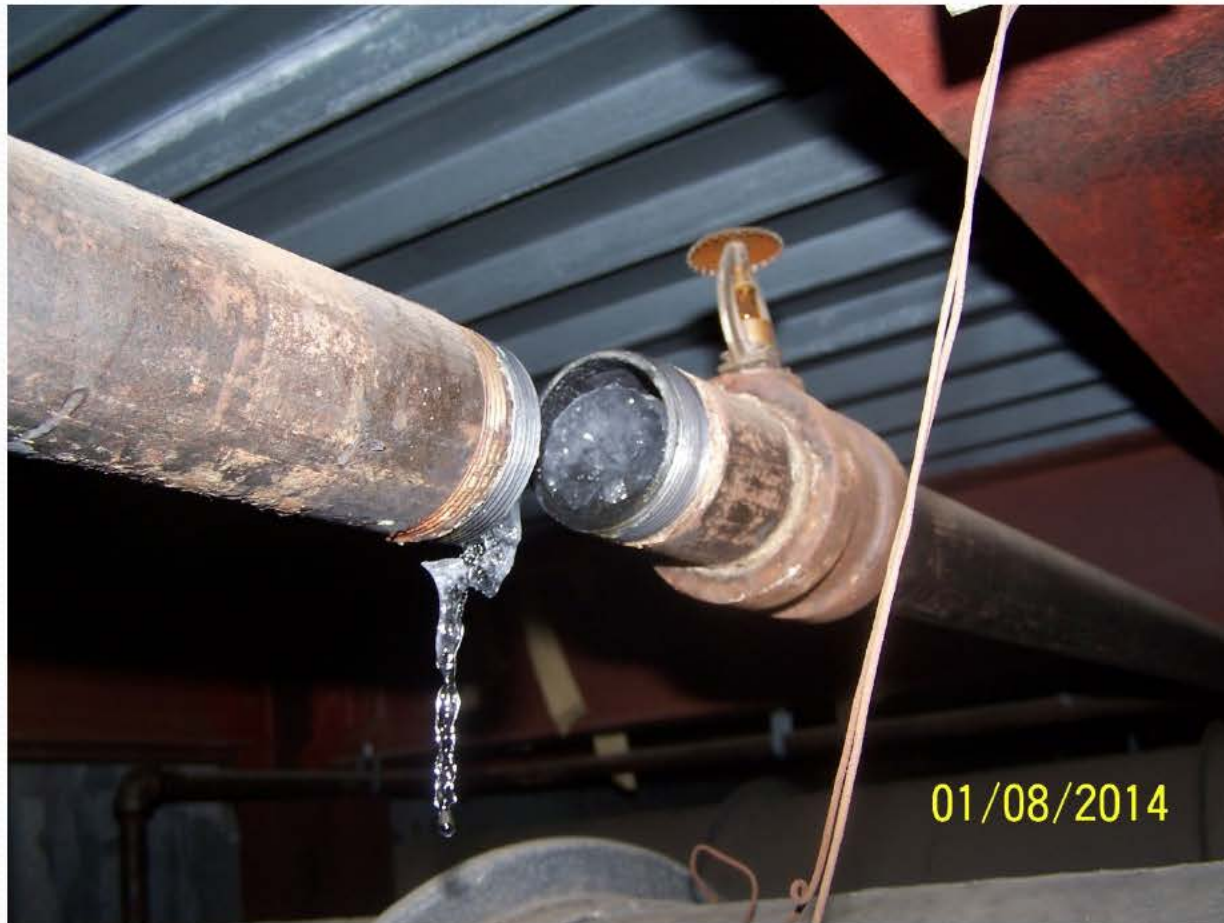
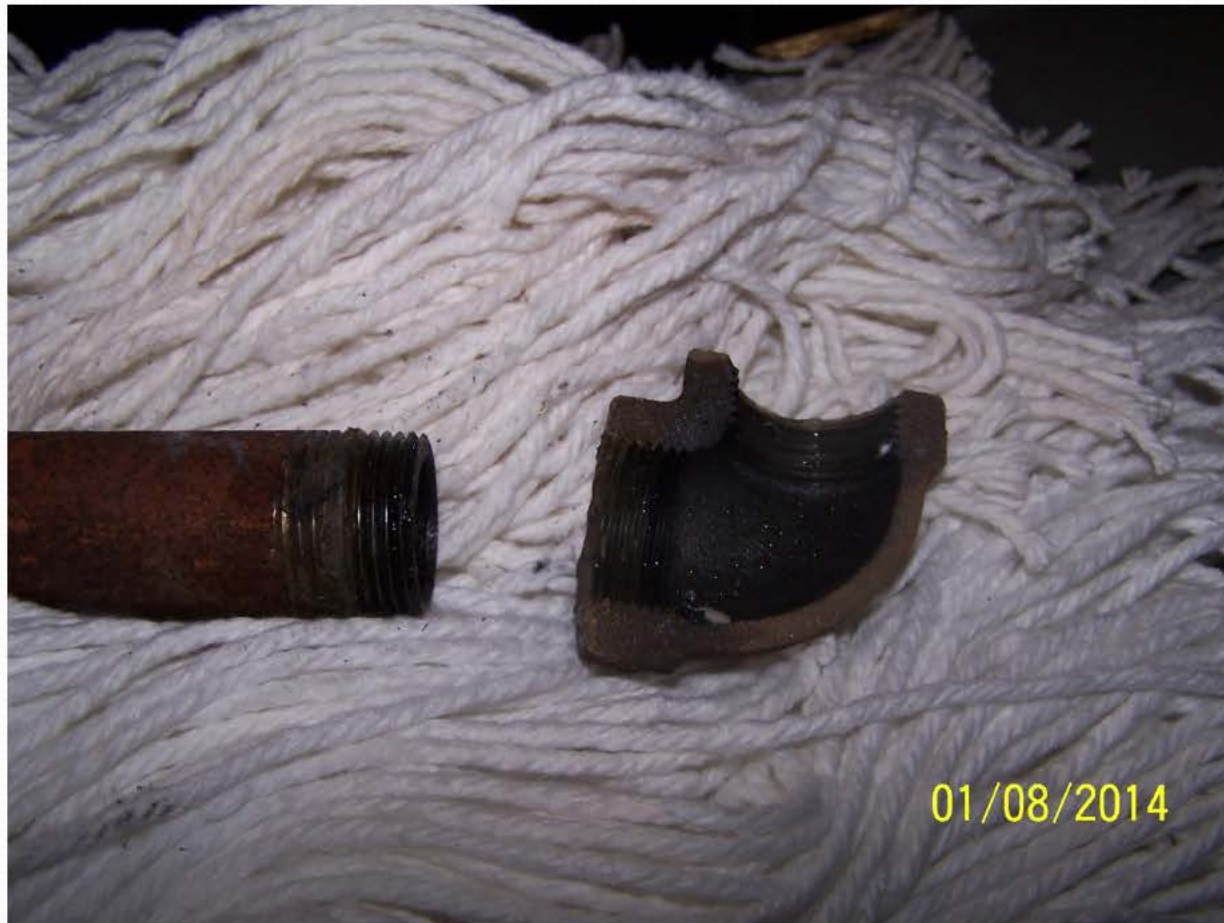
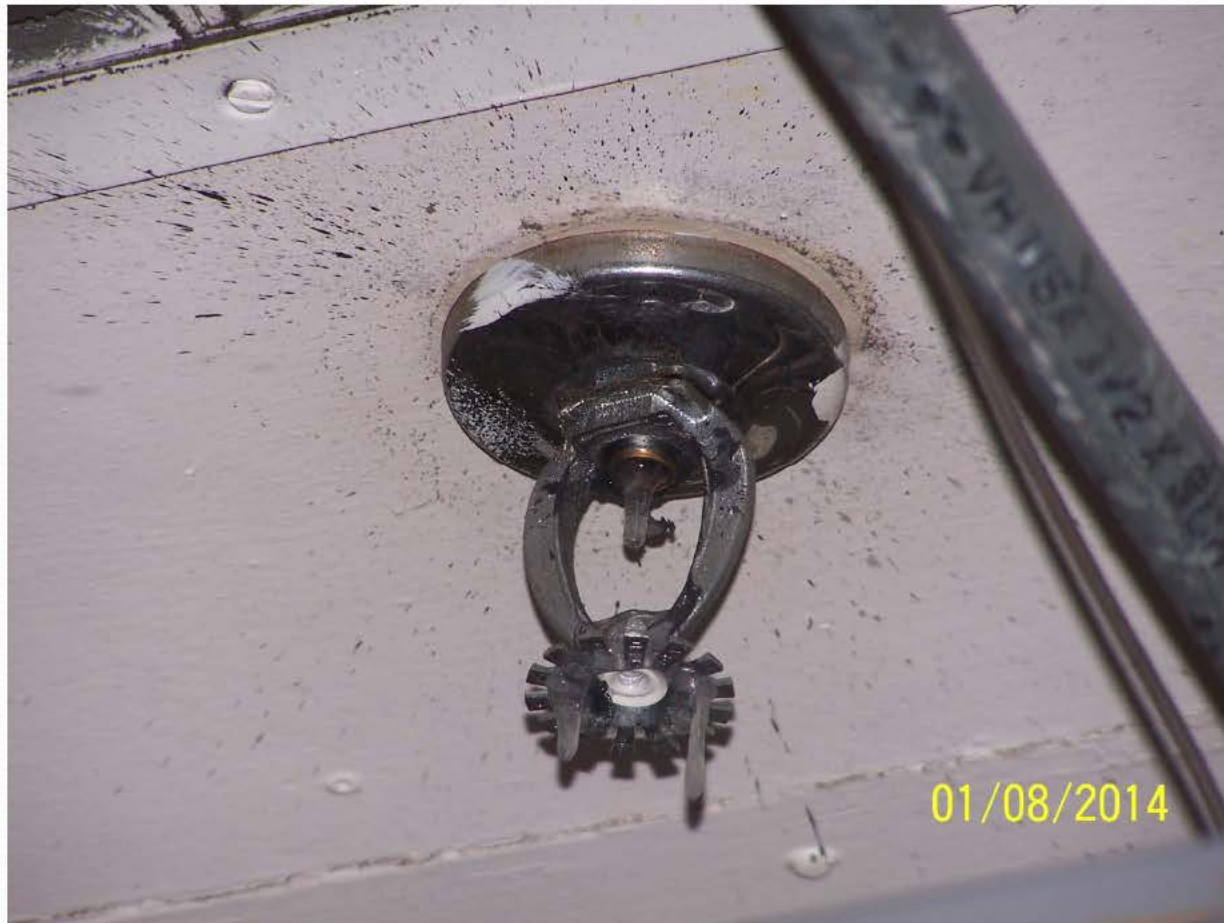
Wet Pipe Suppression System damaged in H-Area Old Manufacturing Facility

All Cooling Coils in both H-Area Old Manufacturing Facility Air Handling Units were damaged beyond repair (14 sets of coils total)

2 of 4 sets of coils damaged beyond repair in H-Area New Manufacturing Facility
